# **Selected Images of the Effects of the October 15, 2006, Kīholo Bay-Māhukona, Hawai‘i, Earthquakes and Recovery Efforts**

Data Series 506

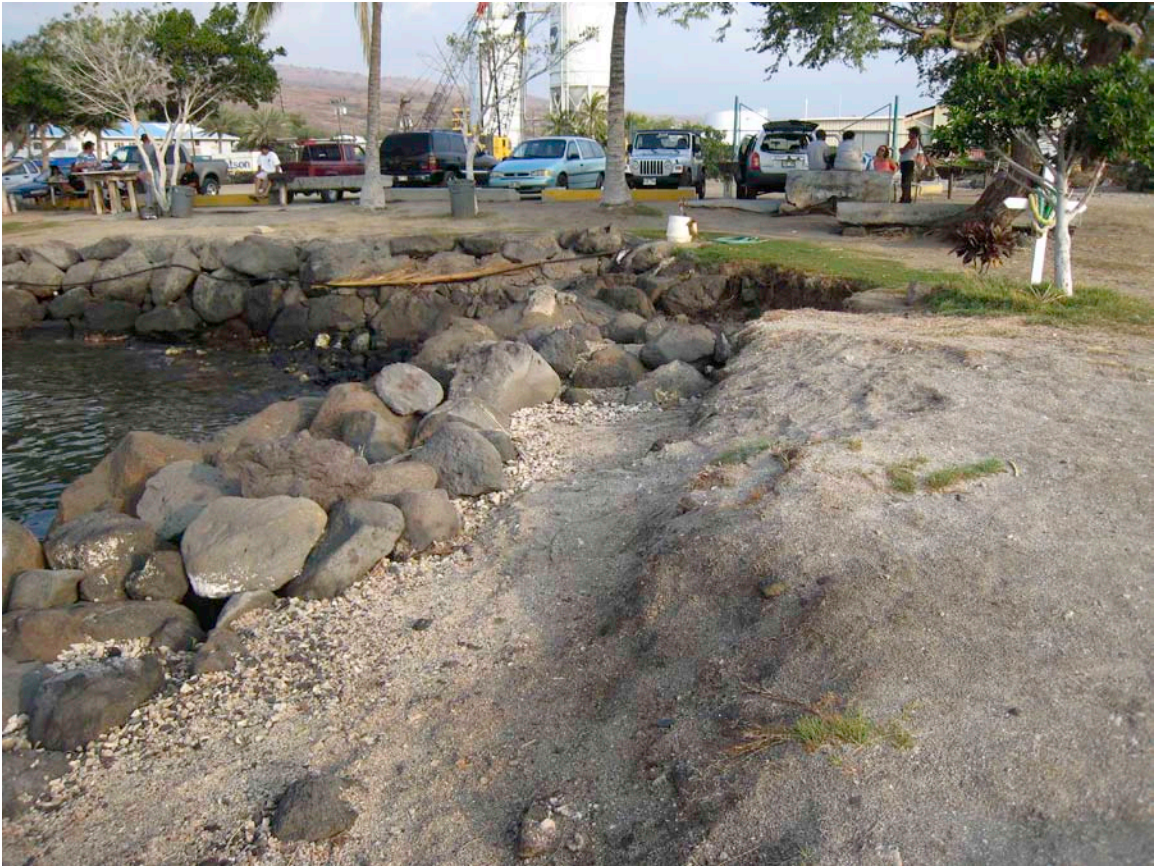
28.11. View of slumping along the rock revetment seawall (view to the east-southeast).  
USGS photo by T.J. Takahashi, 11/28/2008 (tjt789).

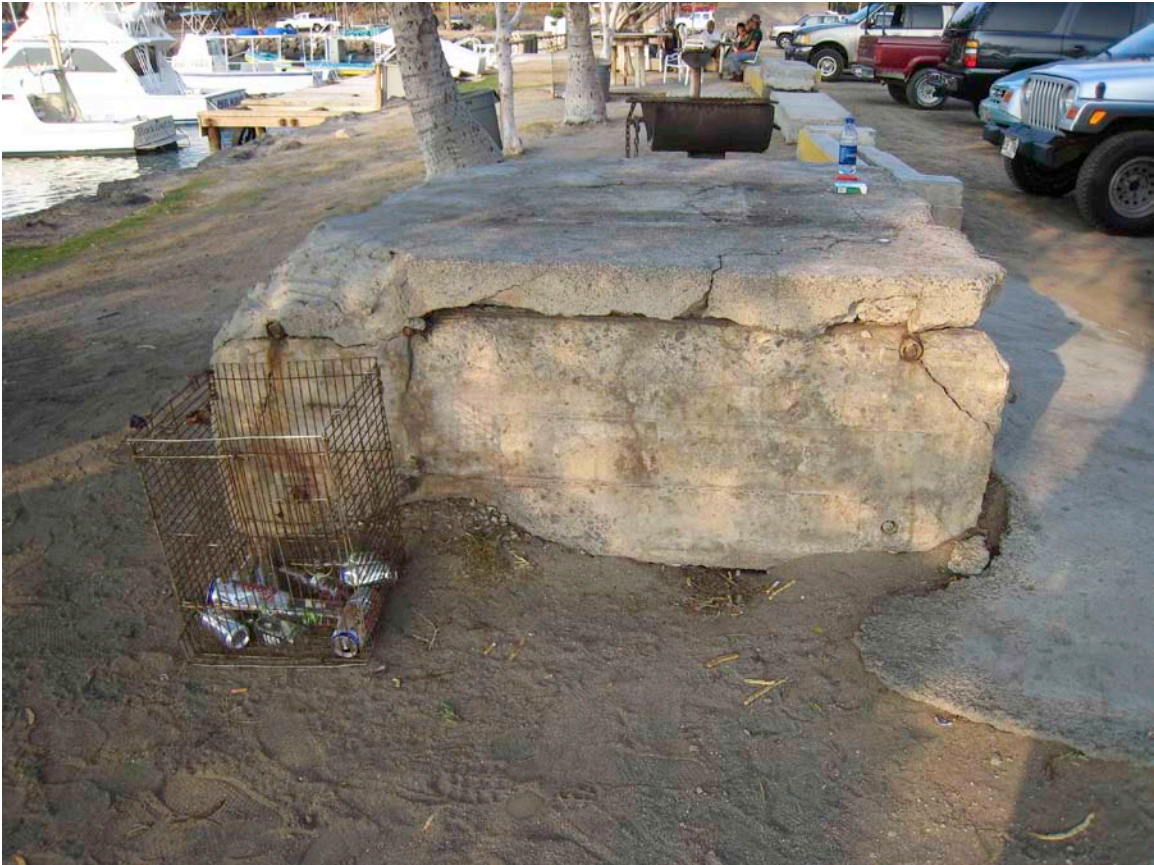
28.12. View of the cracked concrete platform between the seawall at the marginal wharf and the parking lot (view to the north-northeast). USGS photo by T.J. Takahashi, 11/28/2008 (tjt806).

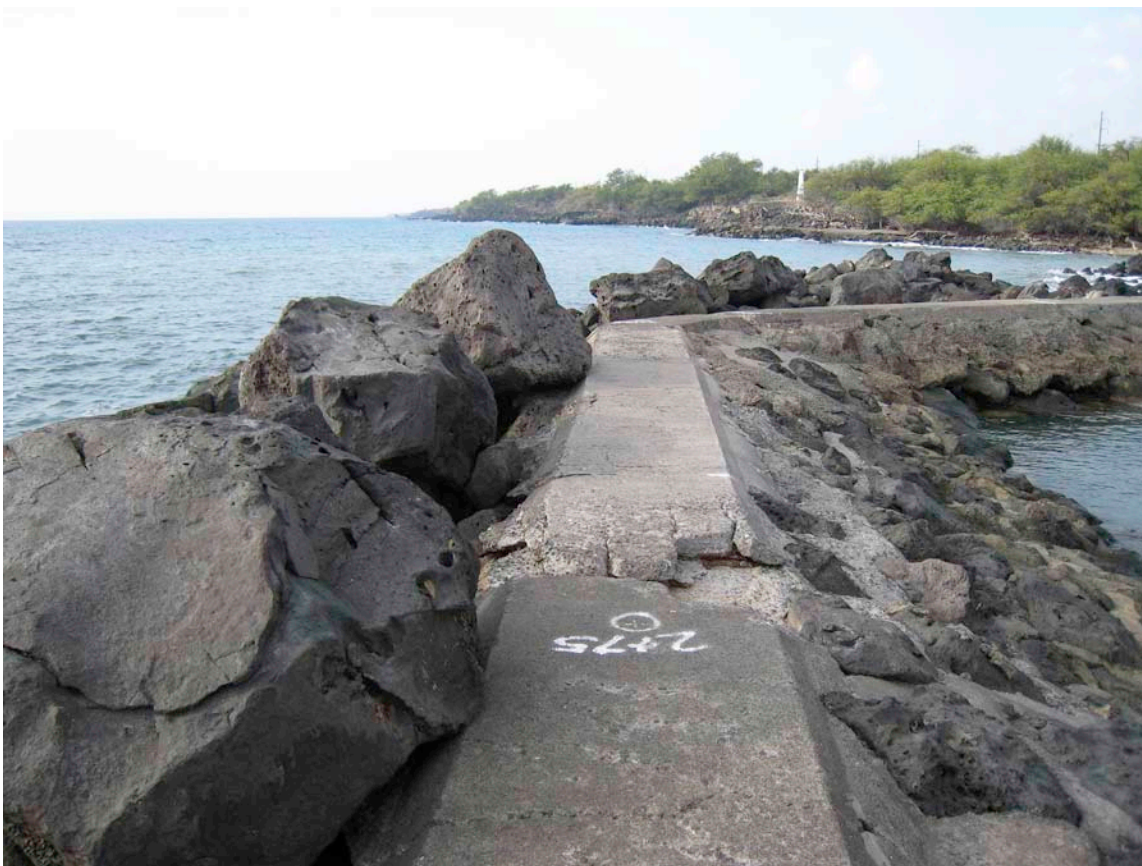
28.20. View of cracks in the concrete pavement upon mortared rocks in the west-side breakwater of the harbor (view to the north-northwest). USGS photo by T.J. Takahashi, 11/28/2008 (tjt703).

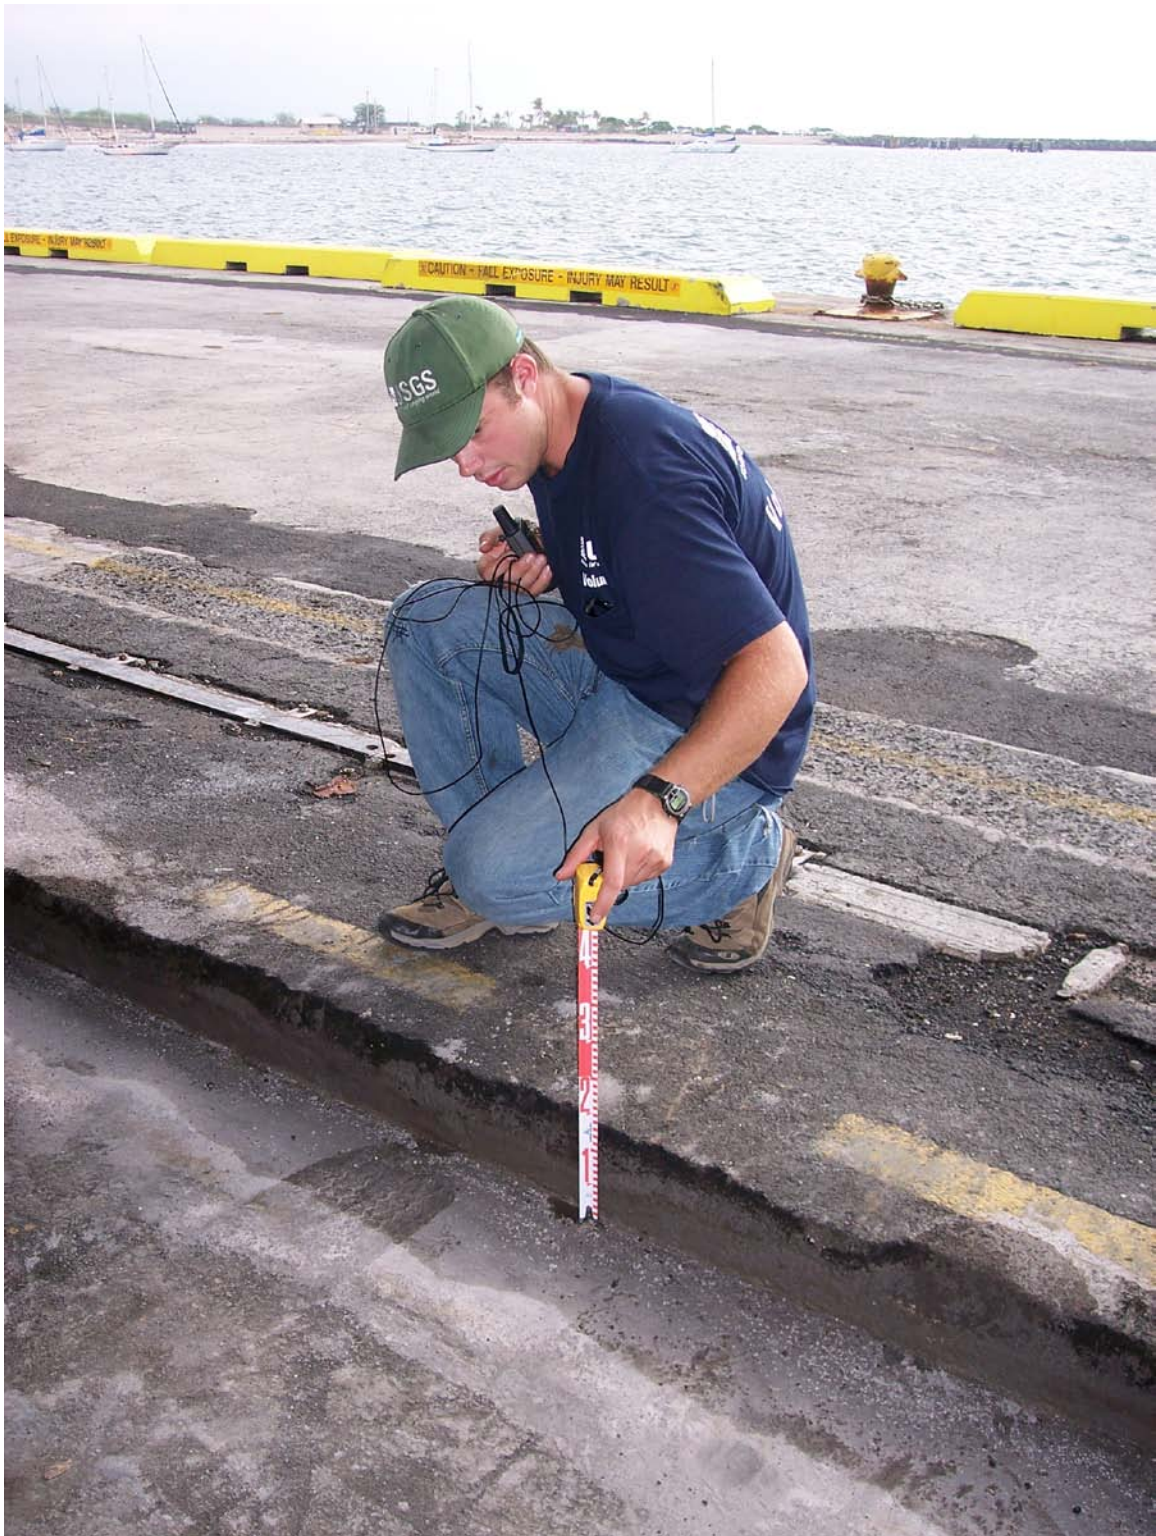
29.4. View of HVO volunteer measuring the subsidence of the pavement—approximately 15 cm (5.9 in.)—at Kawaihae Pier 1 (view to the southwest). USGS photo by T.J. Takahashi, 10/20/2006 (tjt1405).

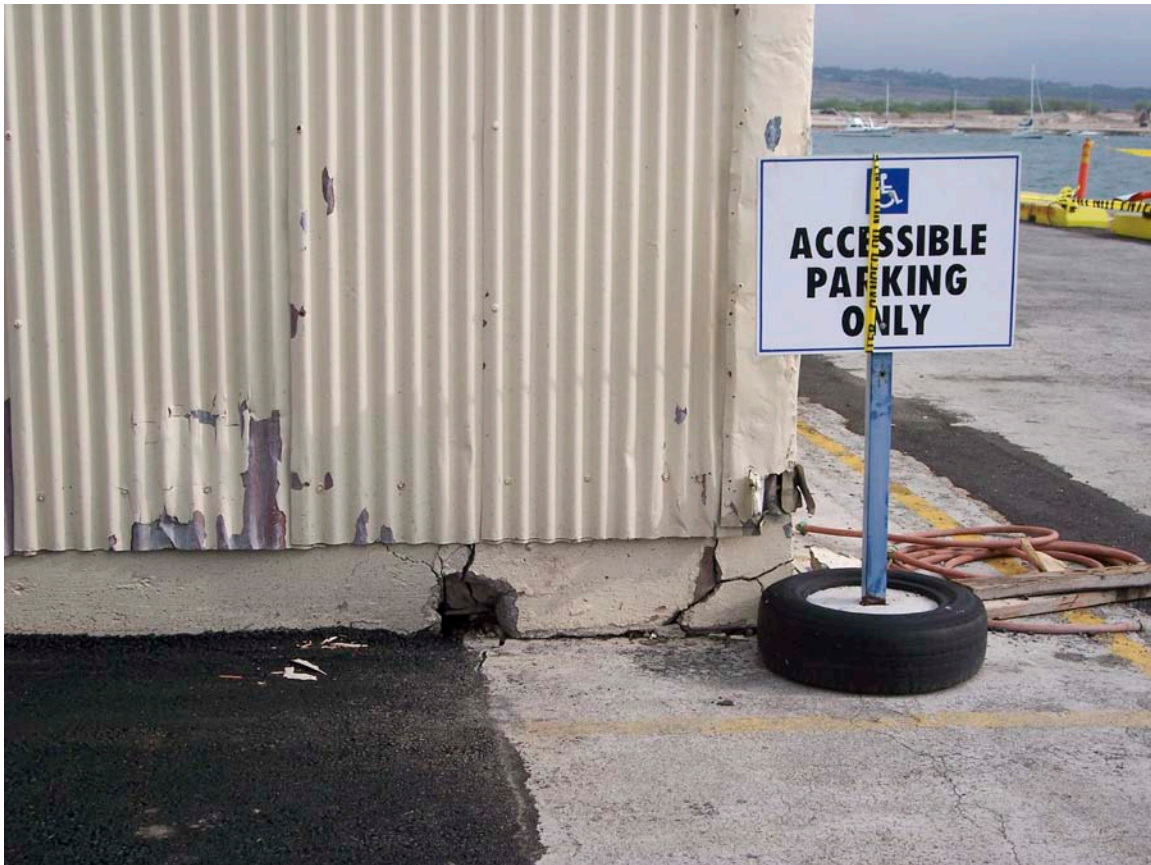
29.5. View of cracks in the northwest corner of the warehouse foundation at Kawaihae Pier 1 (view to the southeast). USGS photo by T.J. Takahashi, 10/20/2006 (tjt1416).

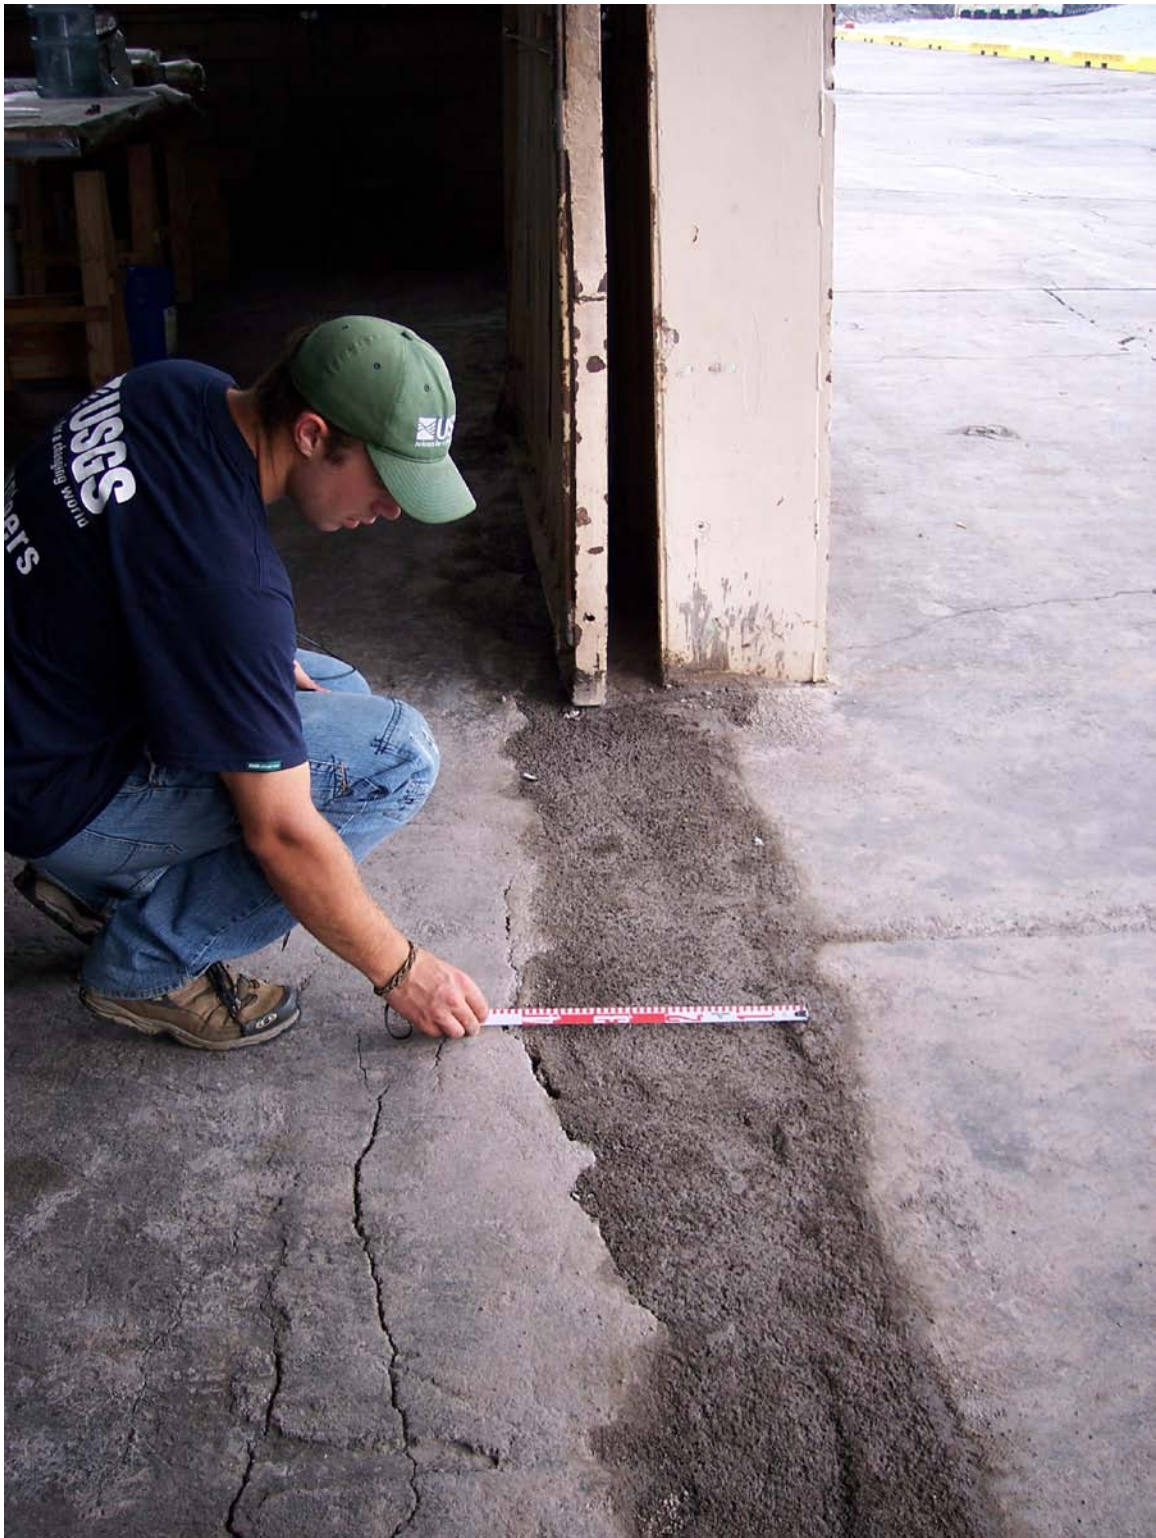
29.6. View of a laterally spreading crack, approximately 0.4-m wide (1.3 ft), in the warehouse threshold (view to the south). USGS photo by T.J. Takahashi, 10/20/2006 (tjt1423).

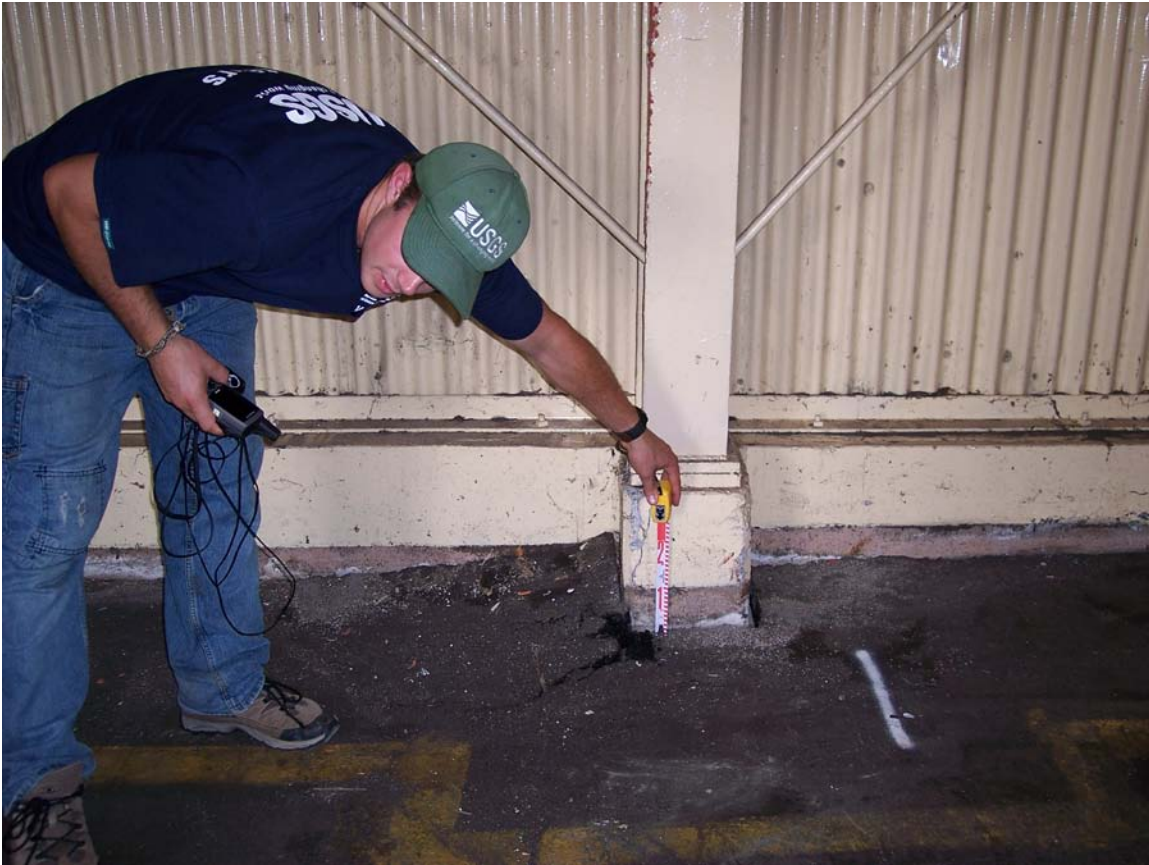
29.7. View of HVO volunteer measuring vertical subsidence, approximately 10 cm (3.9 in.), in the warehouse floor at Kawaihae Pier 1 (view to the west). USGS photo by T.J. Takahashi, 10/20/2006 (tjt1400).

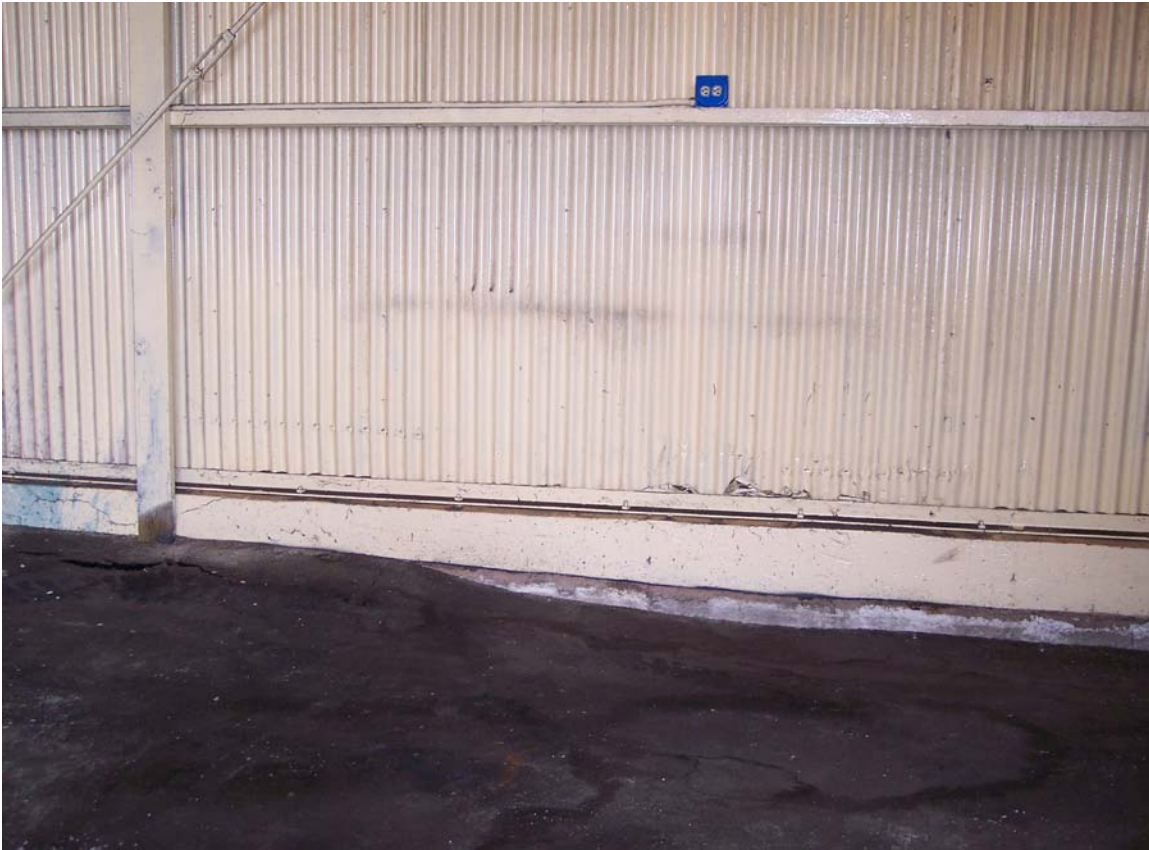
29.8. View of the slumping warehouse floor at Kawaihae Pier 1. The warehouse was demolished in September 2009 (view to the west). USGS photo by T.J. Takahashi, 10/20/2006 (tjt1407).

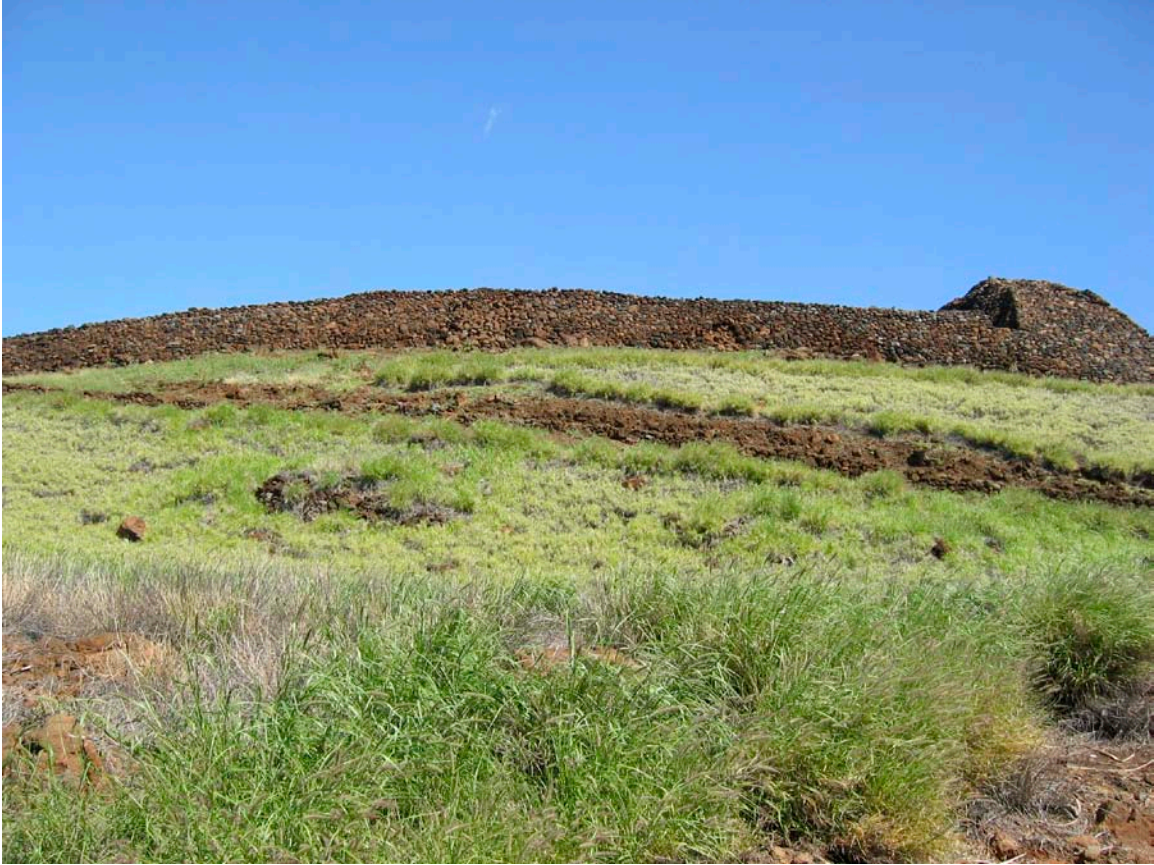
30.5. View of slumping along parts of the west (seaward-facing) wall of Pu‘ukoholā Heiau (view to the east). USGS photo by M.K. Sako, 11/9/2006 (mks008).

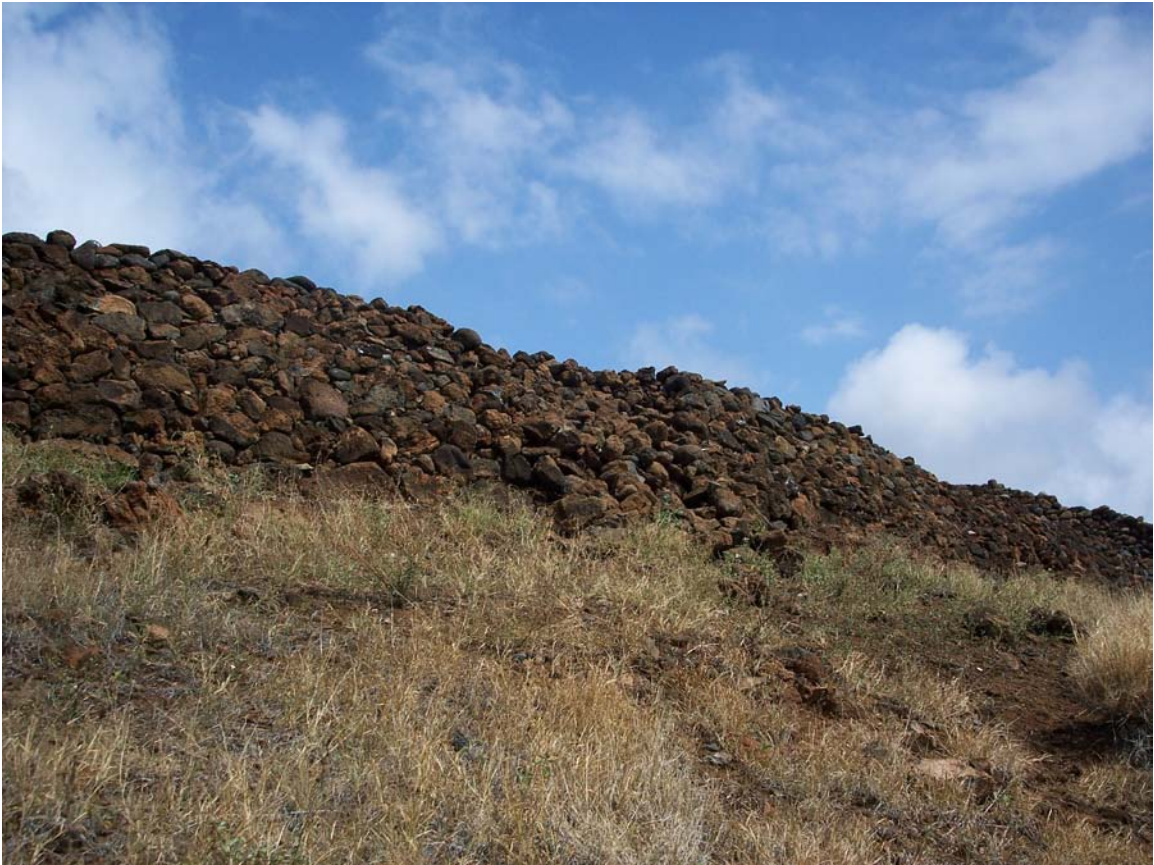
30.6. Close-up view of slumping in the west wall of Pu'ukoholā Heiau (view to the southeast). USGS photo by T.J. Takahashi, 3/12/2007 (tjt3187).

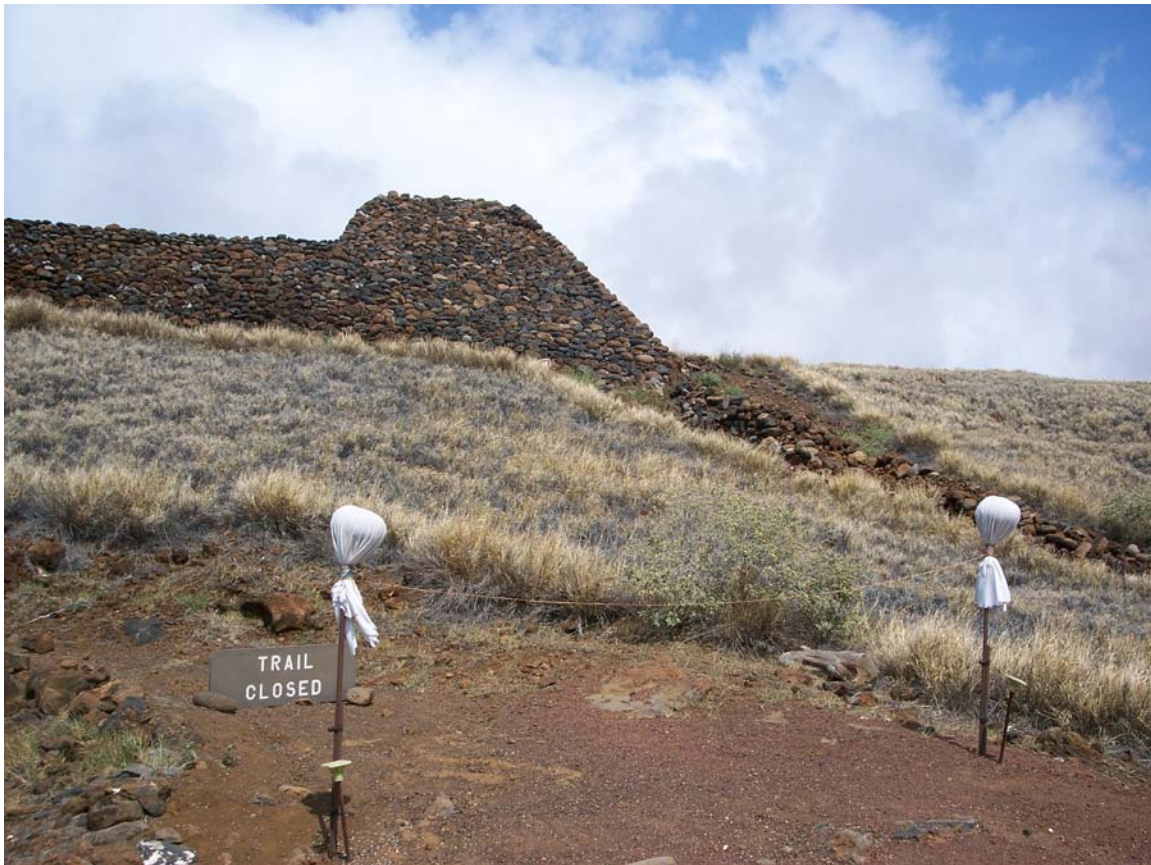
30.7. View of the southwest end of the rock wall at Pu'ukoholā Heiau. The trail was closed due to potential hazards from fallen rocks (view to the east-northeast). USGS photo by T.J. Takahashi, 3/12/2007 (tjt3203).

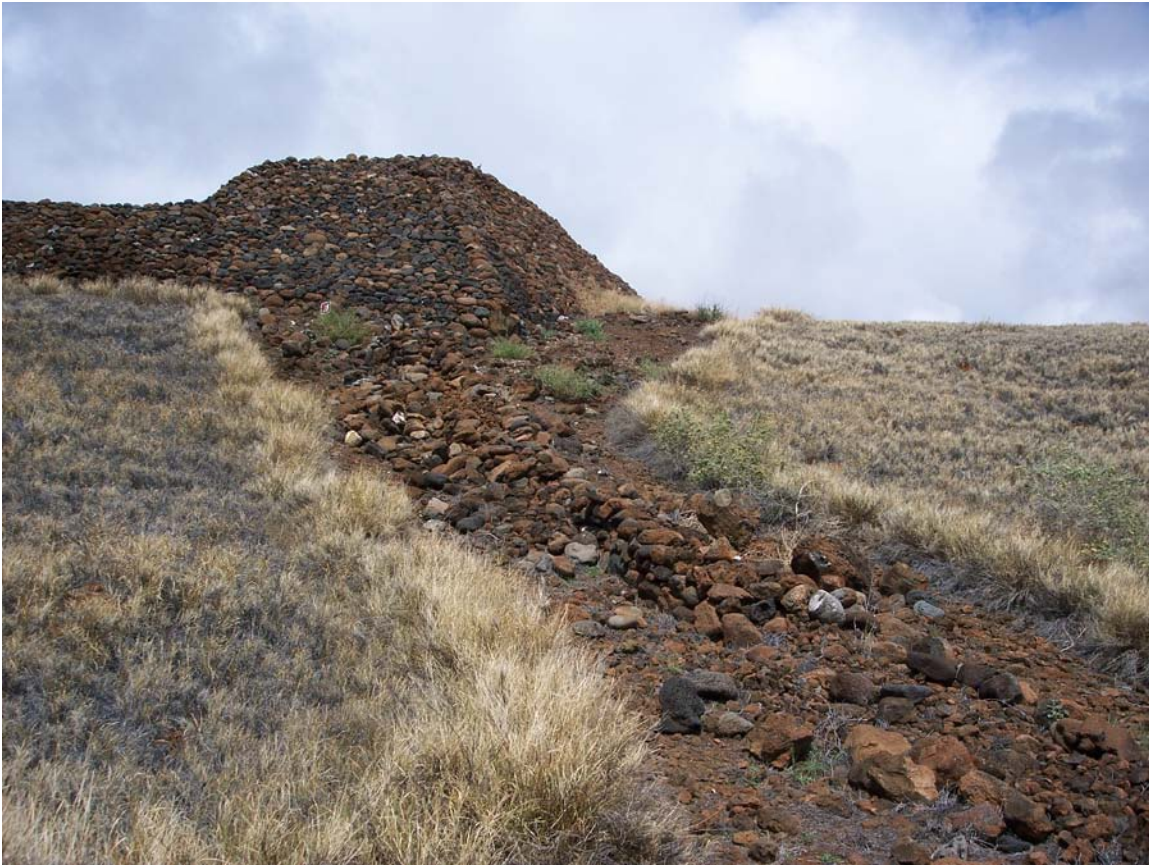
30.8. View of rounded, sea-worn rocks that rolled down the trail from the southwest wall of Pu'ukoholā Heiau. These rocks are part of a collapsed wall that extended out from the heiau (view to the northeast). USGS photo by T.J. Takahashi, 3/12/2007 (tjt3206).

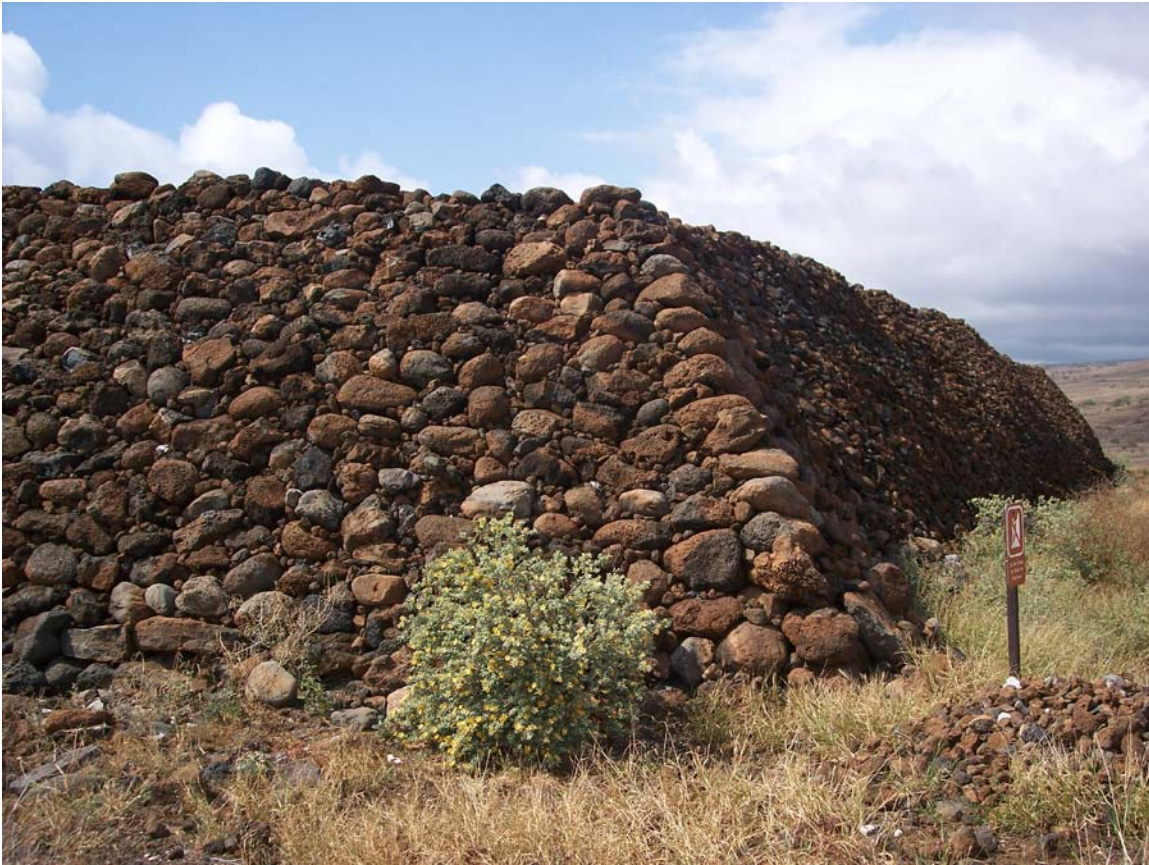
30.10. View of the south (foreground) and adjacent east walls of Pu'ukoholā Heiau. (The sloped walls are broader at the base to ensure stability.) Earthquakes caused rippling along the entire length of the eastern wall. 'Ilima (*Sida fallax* Walp.), a shrub of the mallow family indigenous to drier regions of the tropical Pacific, grows at the southeast corner (Pratt, 1996) (view to the north). USGS photo by T.J. Takahashi, 3/12/2007 (tjt3210).

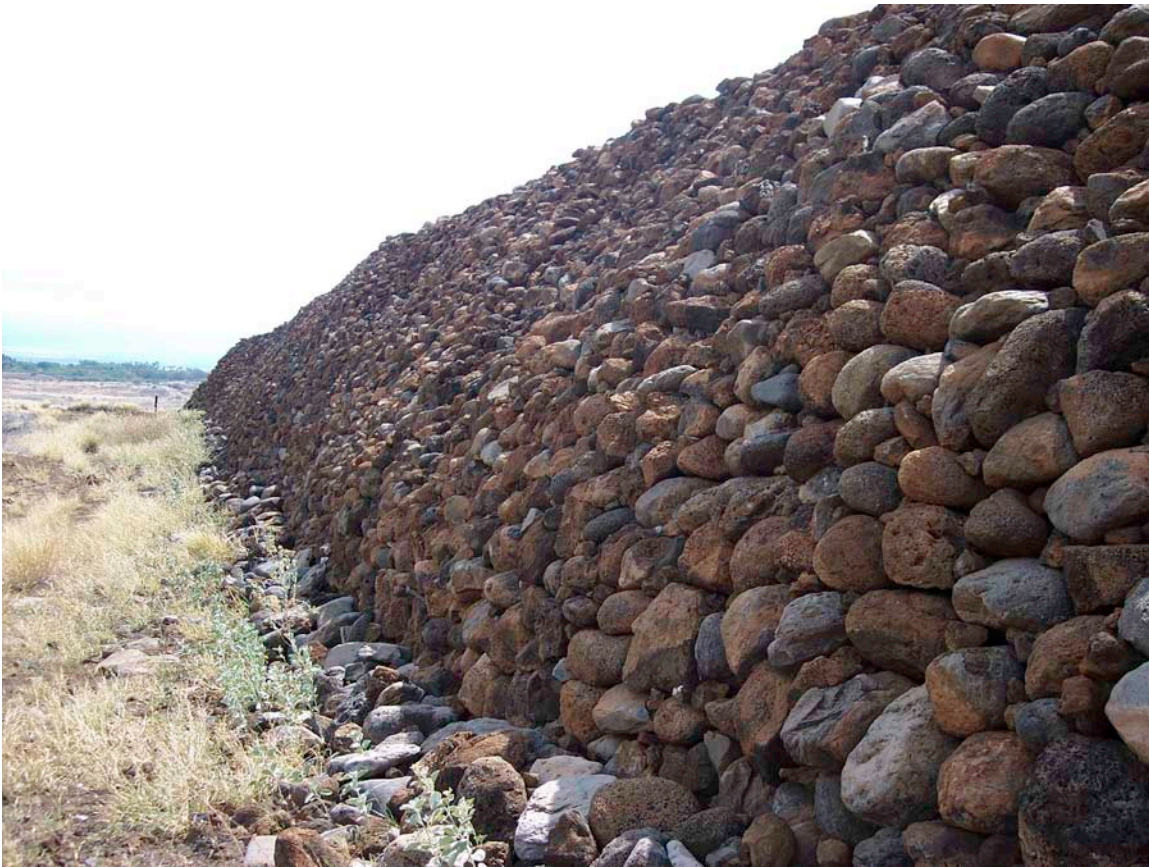
30.11. View of the ripple caused by the earthquake, preserved in the east wall of Pu'ukoholā Heiau. Note the use of smaller, rounded, water-worn stones to fill gaps in the mortarless rock wall (view to the south). USGS photo by T.J. Takahashi, 3/12/2007 (tjt3156).

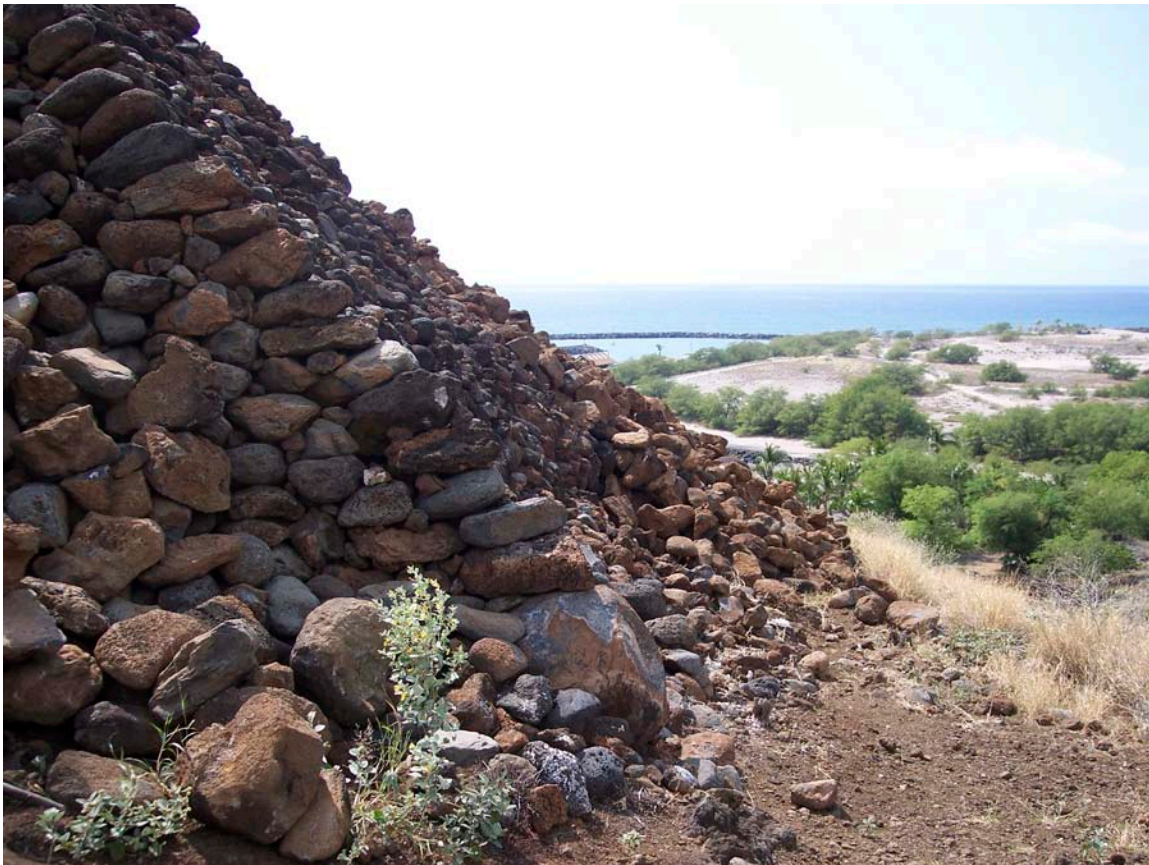
30.12. View of the northeast corner and part of the collapsed north wall of Pu'ukoholā Heiau. Stones from the partially collapsed north wall rolled onto the trail around the base of the structure (view to the west). USGS photo by T.J. Takahashi, 3/12/2007 (tjt3159).

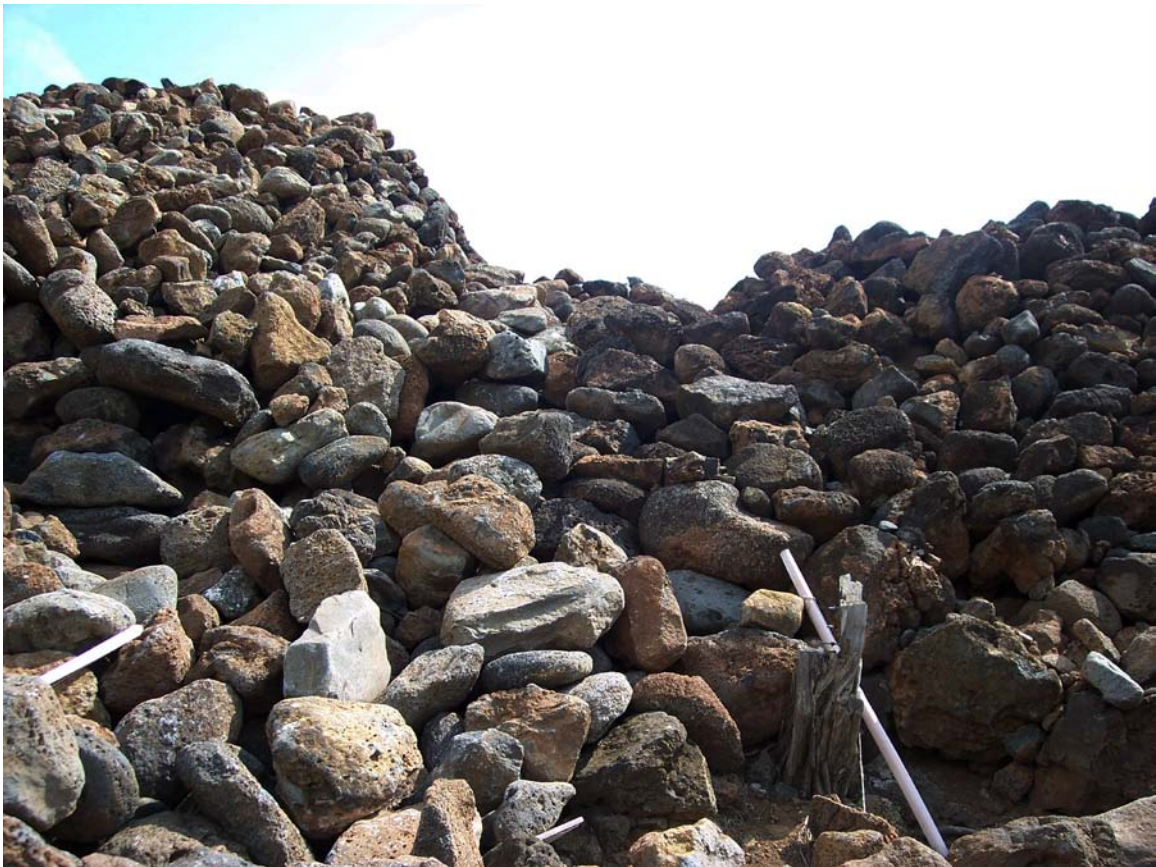
30.13. View of the collapsed entrance into Pu‘ukoholā Heiau along the north wall (view to the south). USGS photo by T.J. Takahashi, 3/12/2007 (tjt3169).

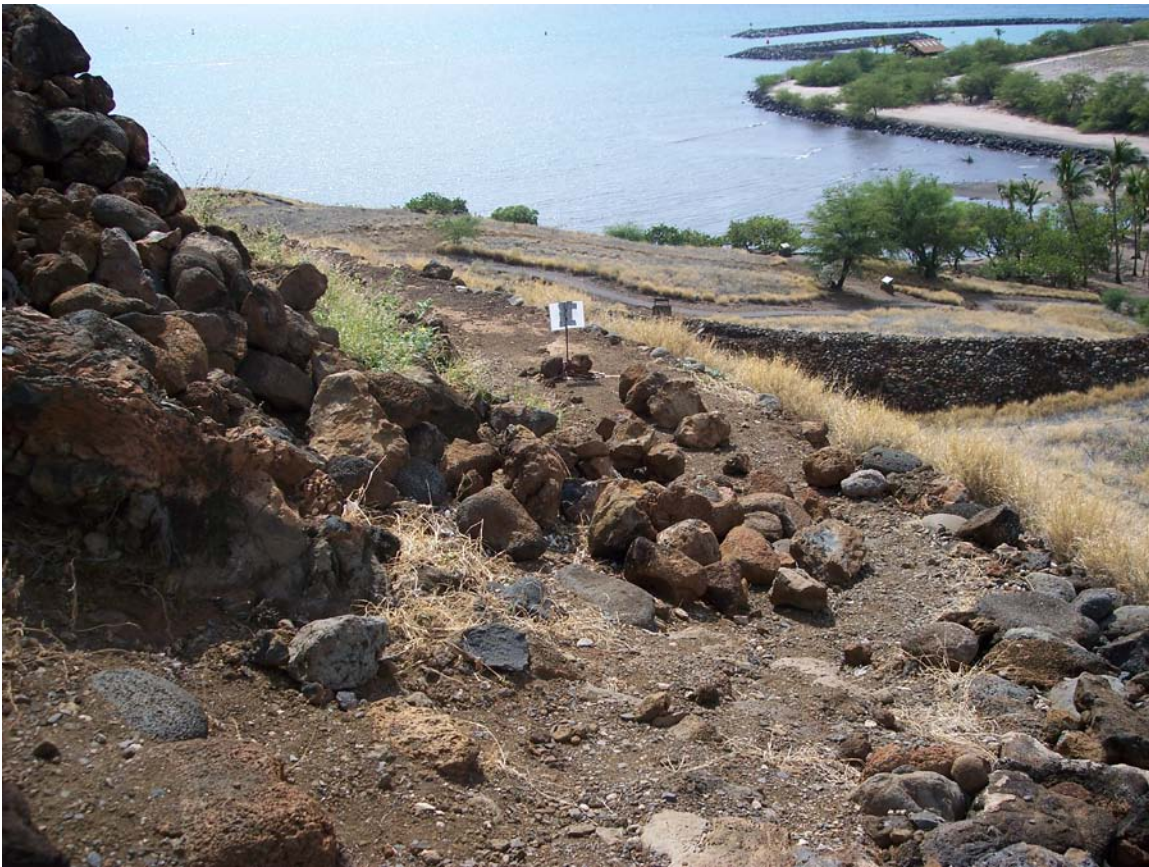
30.14. View of rocks that rolled onto the trail on the north side of Pu'ukoholā Heiau (view to the west). USGS photo by T.J. Takahashi, 3/12/2007 (tjt3176).

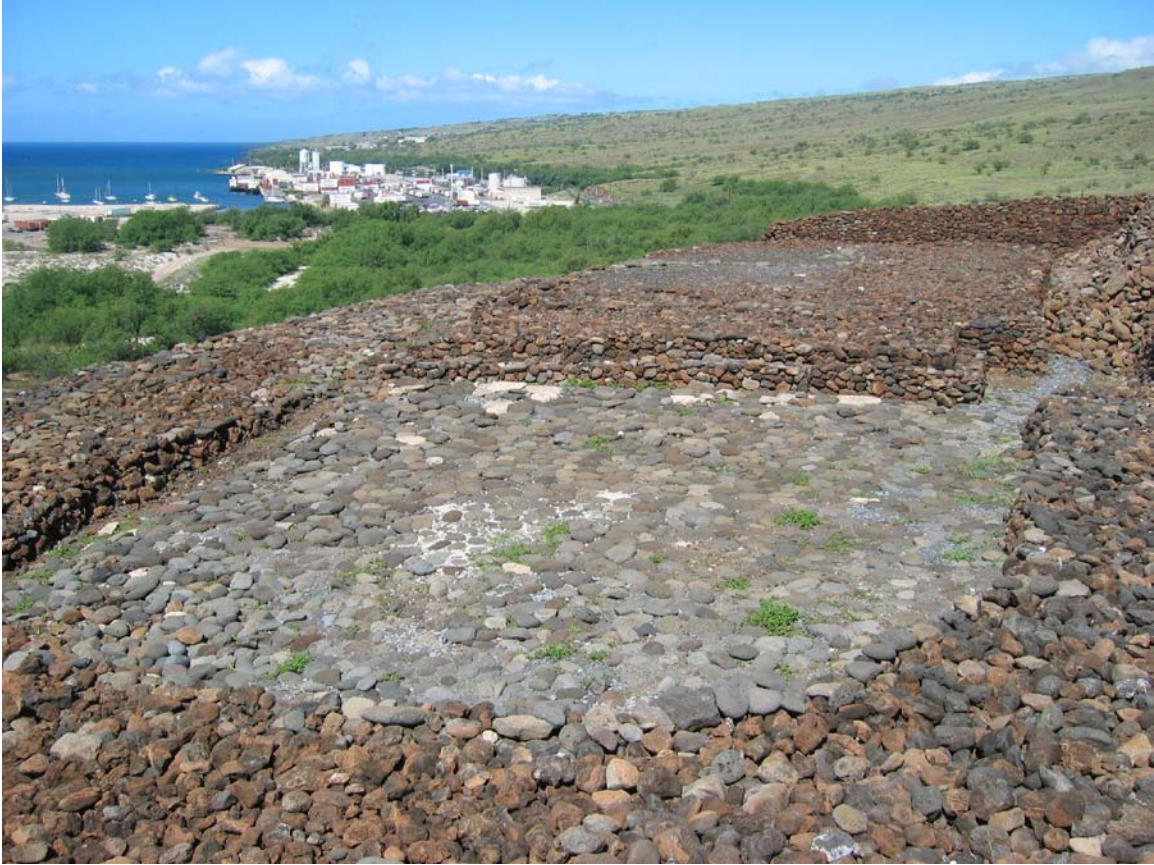
30.15. View of the platform terrace, made up of smooth, flat beach rocks and pebbles (light and dark-gray colors) inside Pu‘ukoholā Heiau. Note the rock slide from the interior of the east wall and the northeast corner (top right edge of the heiau in the photo) (view to the northwest). USGS photo by M.K. Sako, 11/9/2006 (mks002).

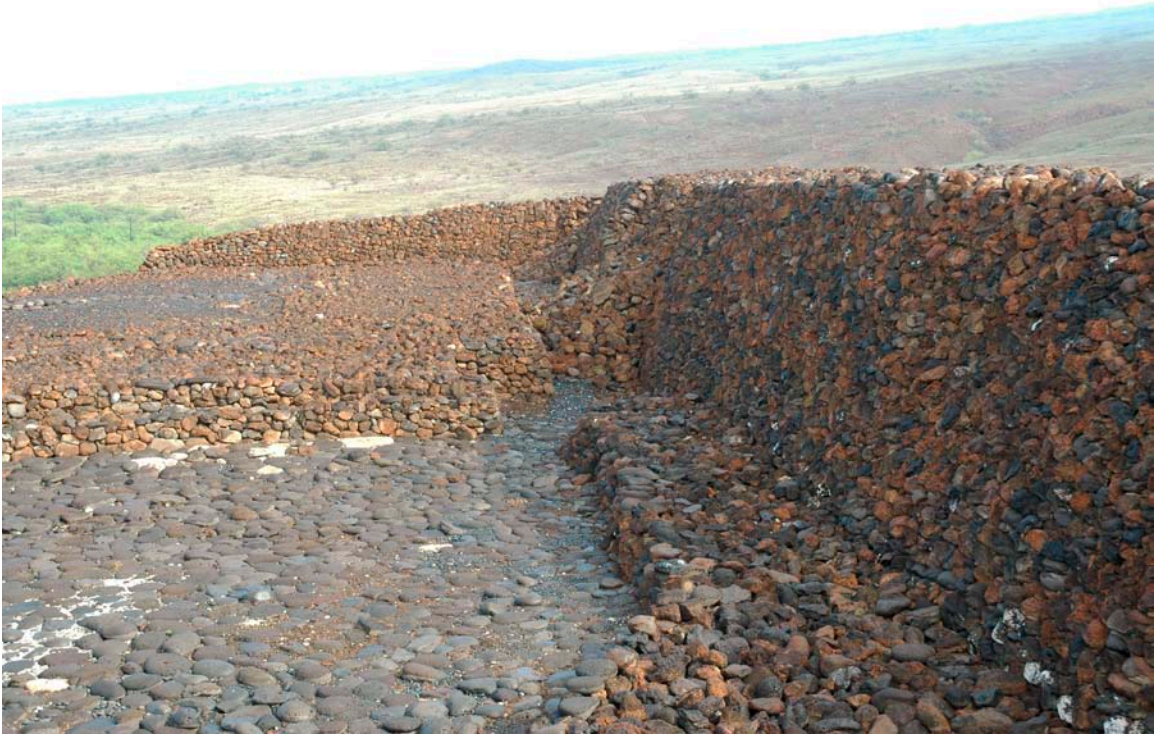
30.16. View of the collapsed interior section of the east wall (to the right of the large platform in the photo) and at the northeast corner of Pu'ukoholā Heiau (view to the north). CSAV photo by D.A. Whilldin, 10/20/2006 (daw031).

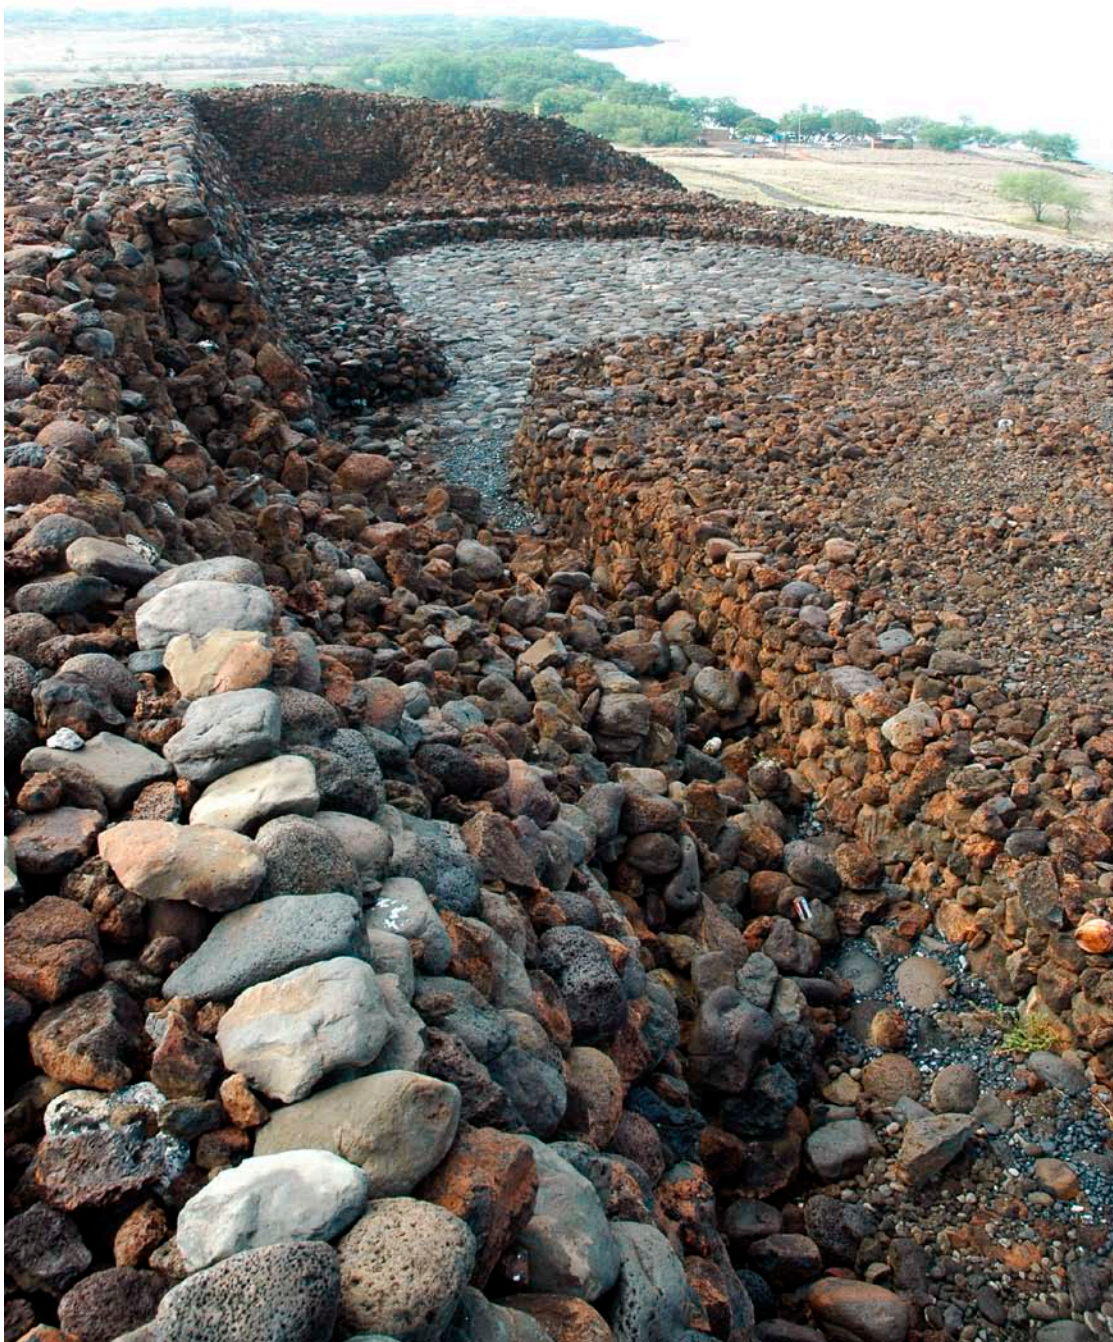
30.17. Interior view of the collapse (foreground in photo) along the east wall (left wall in photo) and the collapsed section of the south wall (rear wall in photo) of Pu'ukoholā Heiau (view to the south). CSAV photo by D.A. Whilldin, 10/20/2006 (daw041).
